METALS HANDBOOK

VOL. 9
FRACTOGRAPHY AND ATLAS OF FRACTOGRAPHY

8th EDITION

Fractography and Atlas of Fractographs

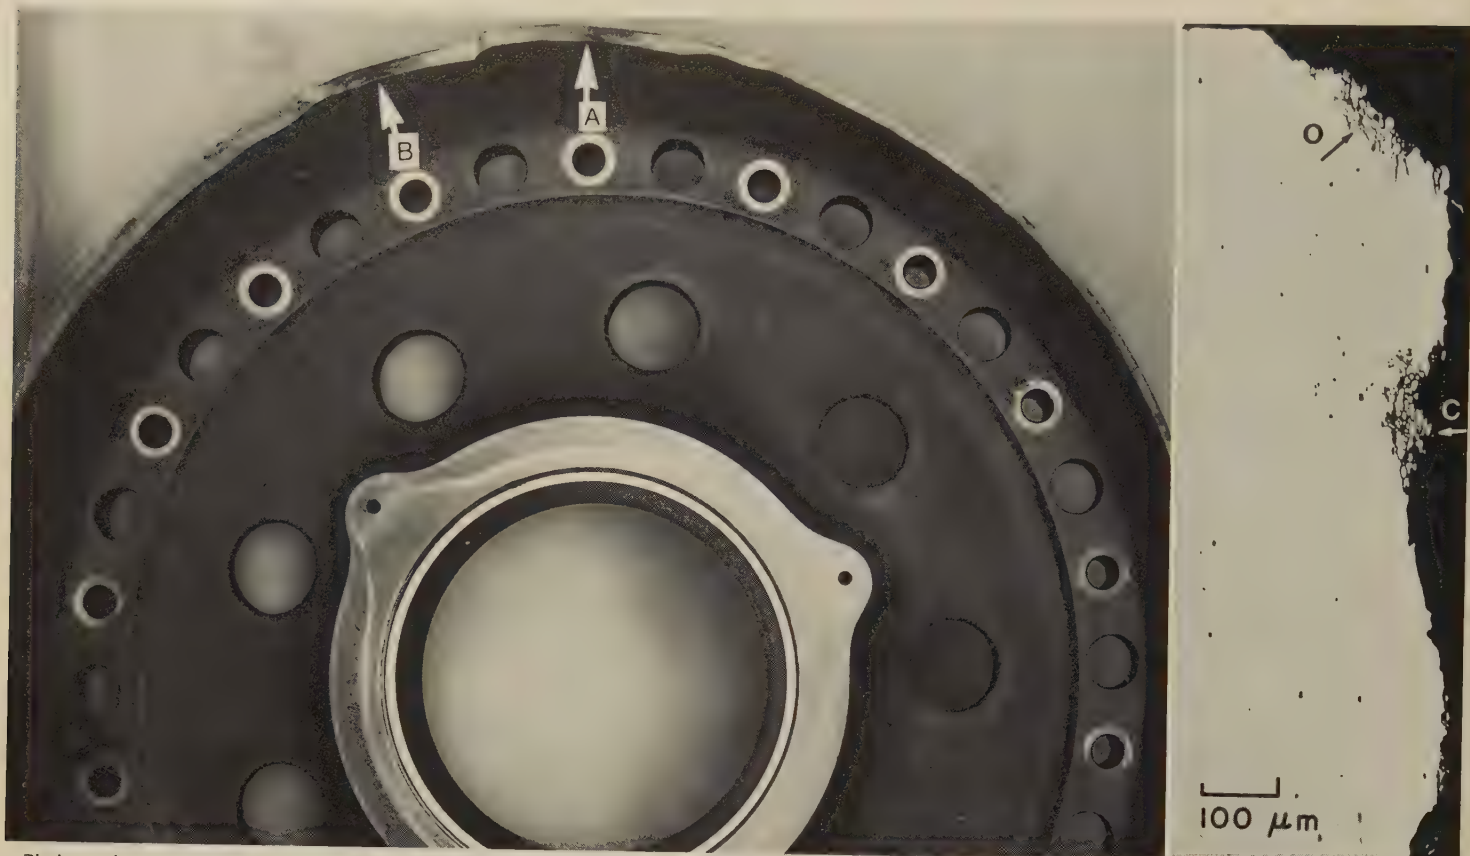
5129, 5130

Hub portion of the outer half of a broken aircraft main-landing-gear wheel forged of aluminum alloy 2014-T6, which fractured by fatigue. The hardness of the wheel measured 133 Bhn (500-lb load). At left (5129) is a view showing the fracture surface. Beach marks at top identify two fatigue-crack origins (at arrows). A section (polished but unetched) through the origin at arrow "b" is shown in 5130 (right), with the fracture surface at top and the inner surface of the wheel at right. The fatigue crack began in the area at "o"; this area, and the area at "c", show evidence of intergranular surface corrosion. See 5131 (below), 5132 (facing page).

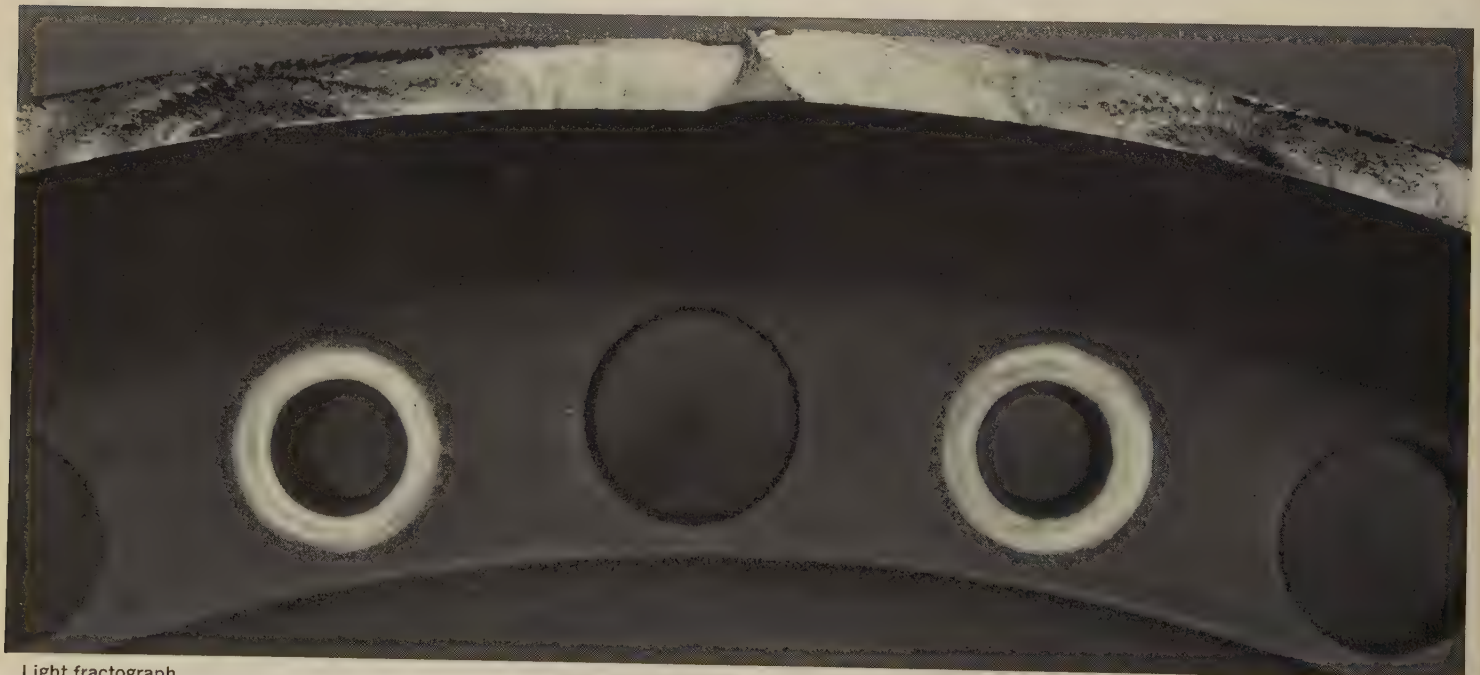
5131

Higher-magnification view of the fractured main-landing-gear wheel half in 5129, showing the two fatigue-crack origins. The fatigue cracks penetrated almost the entire section before final, fast fracture occurred, producing shear lips. Beach marks emanating in both directions from each origin can be distinguished to the limits of this view. Numerous areas of corrosion damage were found on the inner surface of the wheel (not distinguishable here because of the angle of illumination), any of which could have caused stress concentration sufficiently severe to initiate a fatigue crack.

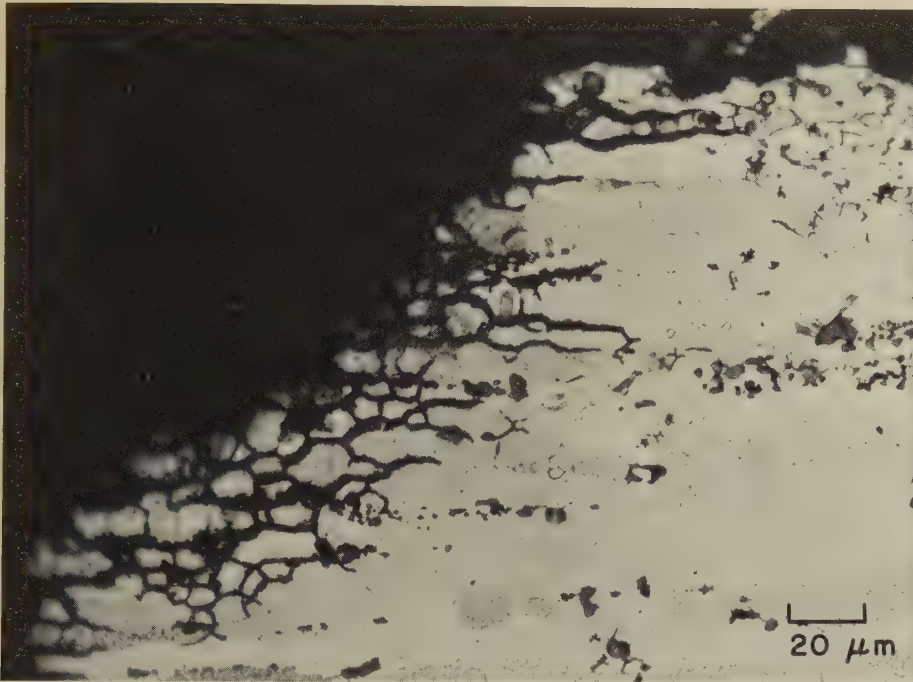
5132 Higher-magnification view of the area in 5130 marked "o", after etching, clearly showing that the corrosive attack of the inner surface of the wheel had produced intergranular cracks typical of those caused by stress corrosion. Such cracks are well-known sources of stress concentrations, which quite often result in the generation of fatigue cracks.

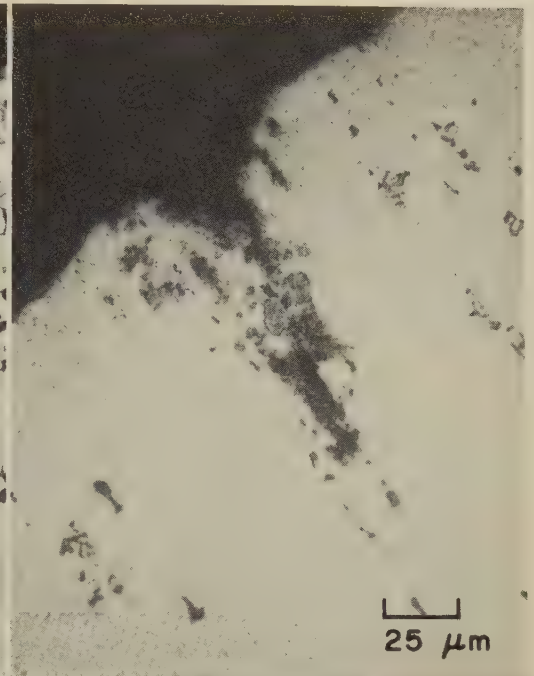
5133 A section through a fatigue fracture in an aluminum alloy 2014-T6 aircraft main-landing-gear wheel similar to that in 5129, showing a corrosion pit typical of several believed to have initiated the fracture.

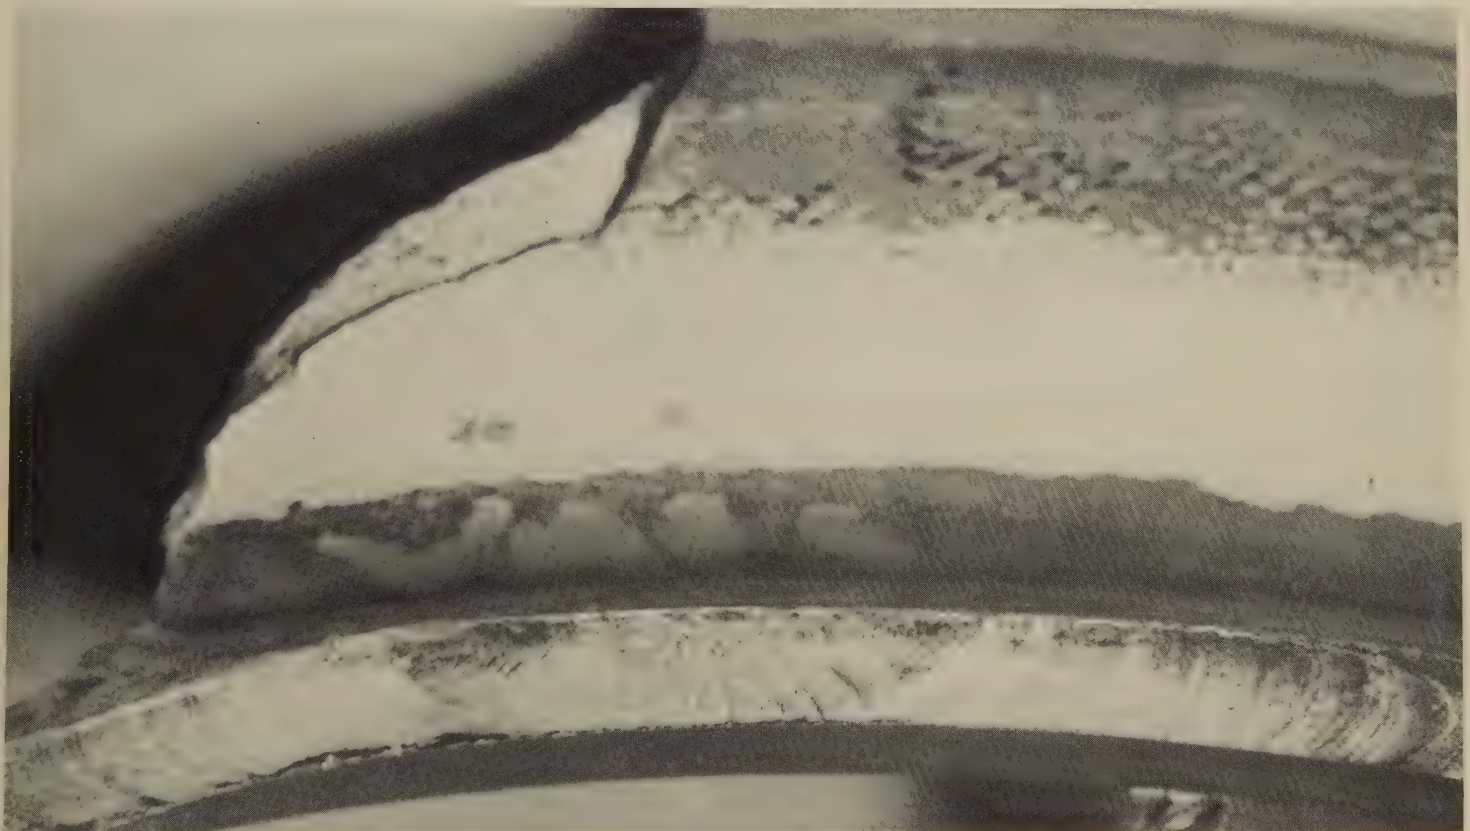
5134 A fragment of the flange portion of a broken half of a forged aluminum alloy 2014-T6 aircraft main-landing-gear wheel similar to that in 5129 (facing page), showing the nucleus of a fatigue fracture caused by corrosion pits similar to the pit shown in 5133 (above, at right). Beach marks are very clearly visible in the fatigue zone. The fracture propagated completely around the wheel in the tube-well area, separating the flange portion from the hub portion.

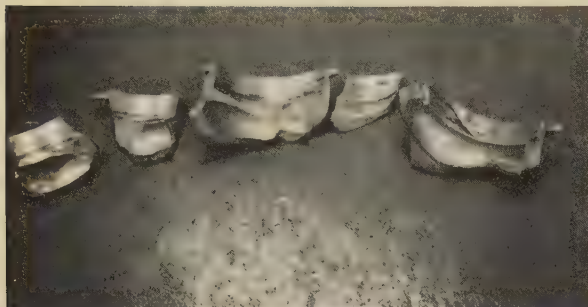
5135 Pieces of the hub of a forged aircraft main-landing-gear wheel half, which broke by fatigue. The material is aluminum alloy 2014-T6. Tensile specimens from elsewhere in the wheel had tensile strength of 493.7 MPa (71.6 ksi) and 8.9% elongation in the transverse direction, and tensile strength of 466.1 MPa (67.6 ksi) and 8.0% elongation in the longitudinal direction. See also 5136.

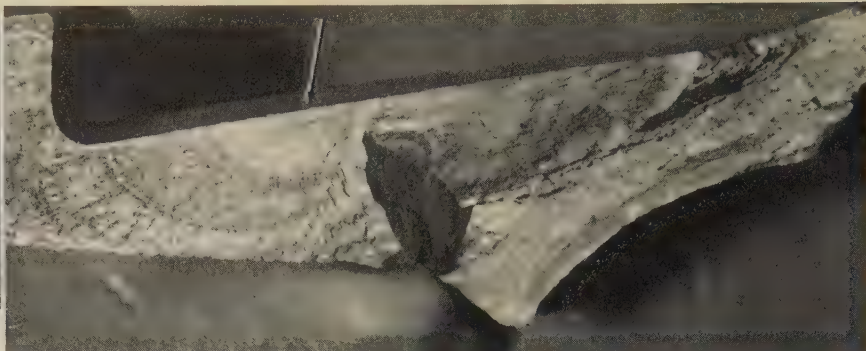
5136 View of an area of one fracture surface of the broken hub in 5135 (at left), showing the fatigue-crack origin. Visible are beach marks, which suggest that the origin is at the location marked by the arrow, presumably at one of several corrosion pits that were found on the surface of the hub. After having penetrated a short distance, the fatigue crack developed a step (dark facet); a second fatigue crack originated at one end of the step.

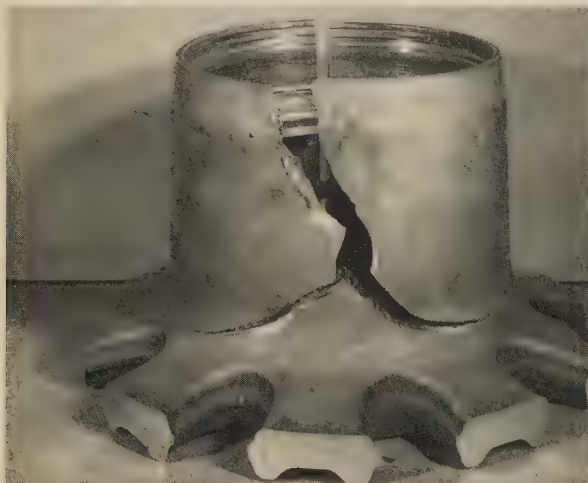
5137, 5138 At left (5137) is the hub of a forged aluminum alloy 2014-T6 aircraft main-landing-gear wheel half, which broke in fatigue. A tensile specimen machined from the hub had tensile strength of 499.2 MPa (72.4 ksi), 12.1% elongation, and hardness of 143 to 150 Bhn, which are acceptable. The fatigue crack originated at the inside surface of the hub. At right (5138) is a fracture surface of the broken hub, showing the fatigue-crack origin. Clearly visible are beach marks, which indicate that the fracture began as a radial fatigue crack, in a plane containing the axis of the wheel. Later, the crack turned to form a circumferential separation between the hub and web of the wheel half, as shown in 5137. See also fractographs 5139 and 5140, below.

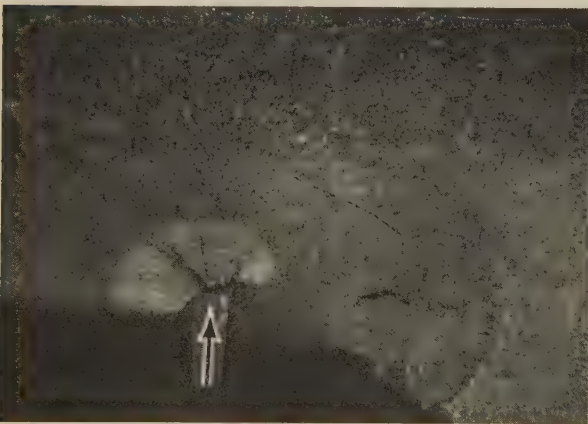
5139 Enlarged view of the fatigue-crack origin in 5138, which plainly shows the region of initial penetration (light area). At arrow is a forging defect usually known as a bright flake. Note that grain flow is approximately parallel to the flake.

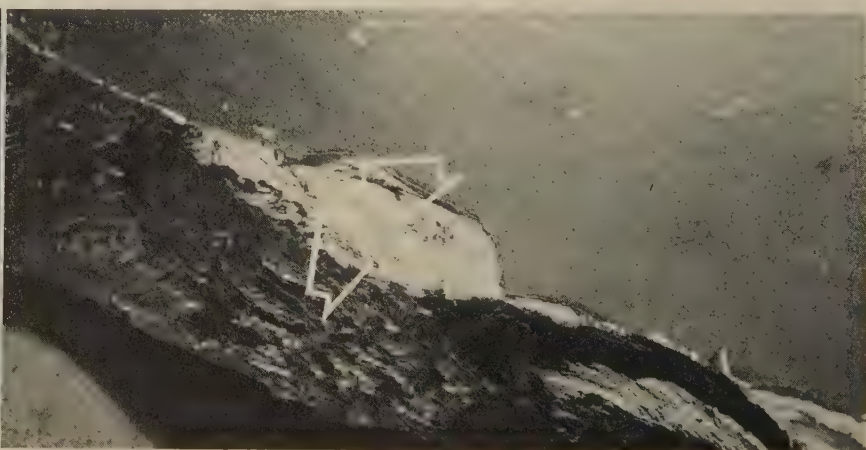
5140 A fracture surface of the broken hub in 5137, showing an area of the circumferential separation between the hub and web. Bright flakes, similar to the defect that initiated the fatigue crack in 5139, are visible at the arrows. These defects have been attributed to hydrogen damage.

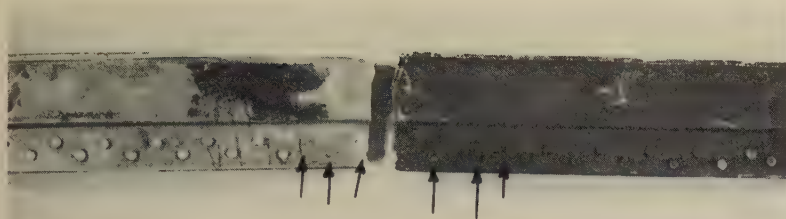
5141 Top surface of an extruded aluminum alloy 2014-T6 bottom cap of an aircraft wing spar, showing a fatigue fracture, at center, which intersected one of the rivet holes indicated by the arrows. Hardness tests near the fracture gave an average value of Rockwell B 85, which is acceptable. See also 5142 through 5146.

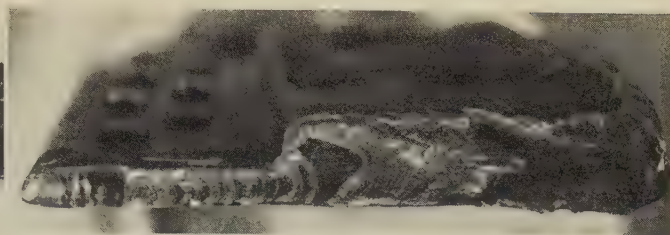
5142 A view of the fracture surface at left in 5141. The rivet hole intersected by the fracture is abnormal, consisting of two overlapping holes (see 5143). Beach marks, which are clearly visible, indicate that the fatigue crack began at the double-drilled rivet hole.

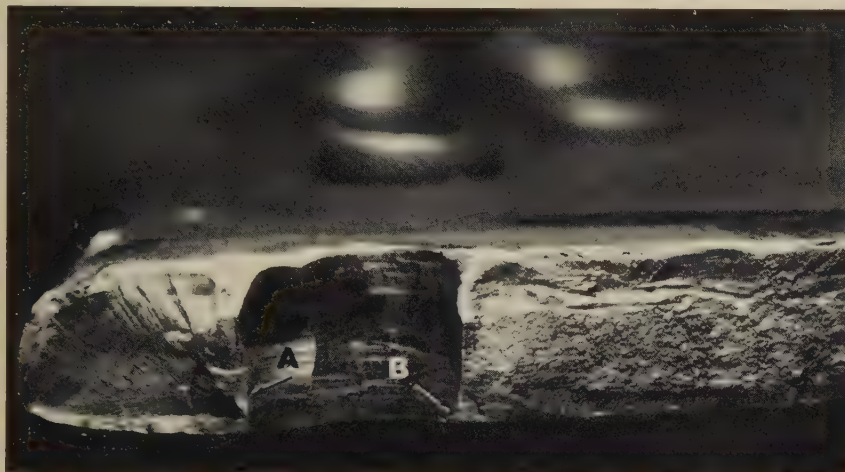
5143 A higher-magnification view of the rivet-hole area of the fracture surface shown in fractograph 5142. The double-drilled nature of the rivet hole is shown quite clearly here. Two fatigue cracks originated at this hole — one beginning at arrow A and growing to the left, and the other beginning at arrow B and growing to the right.

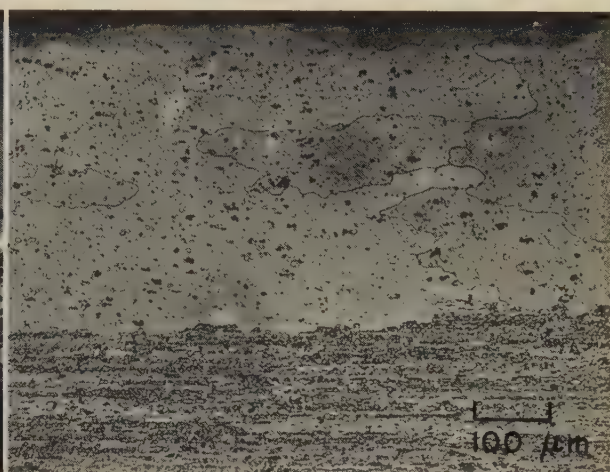
5144 Polished and etched section through the cap in 5141. At bottom is a fibrous interior structure typical of aluminum alloy extrusions. At top is one of the coarse-grained, recrystallized layers, 0.018 to 0.037 in. thick, at the top and bottom surfaces of the cap.

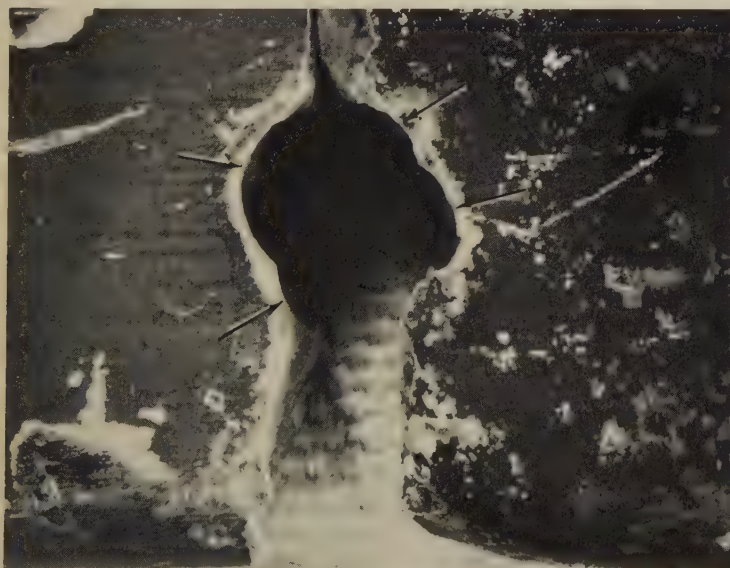
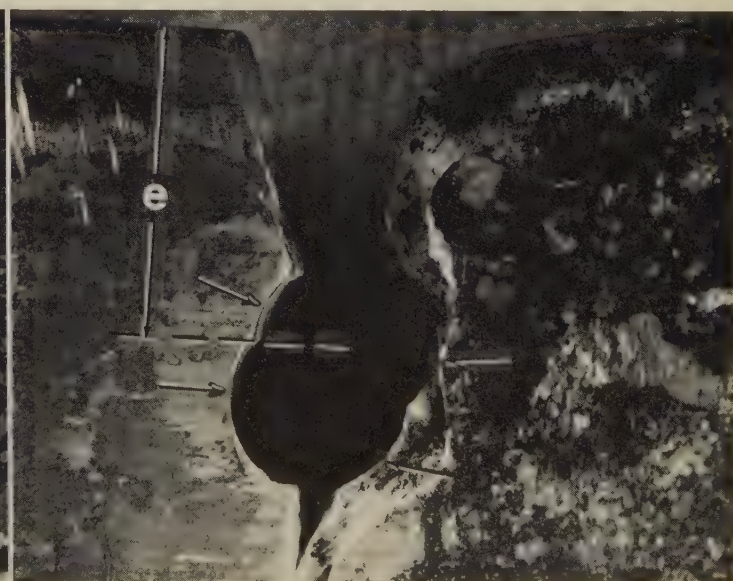
5145, 5146 Views of the top surface (5145, left) and bottom surface (5146, right) of the wing-spar cap in 5141, with the mating fracture surfaces fitted together. The segment at right in each view was deformed after fracture, causing the gap. The double drilling of the rivet hole, noted in 5142 and 5143, is clearly shown (arrows). The edge distance, "e", was measured for each hole (as shown in 5146 for the hole closer to the edge). Edge distance for the hole farther from the edge is about 5/16 in. — the minimum allowed for rivets of the size used here (5/32 in. diam). For the closer hole, edge distance is about 75% of the minimum value, which increased the stresses in that section to excessive levels.

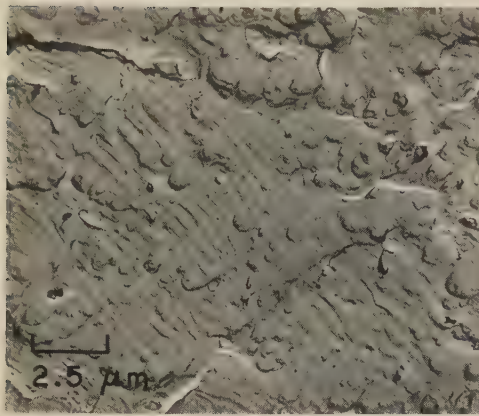
TEM fractograph (p-c replica) 4000×
5147 Surface of a fracture in a specimen of aluminum alloy 2024, showing tear dimples, resulting from microvoid coalescence, scattered among somewhat irregular fatigue striations.

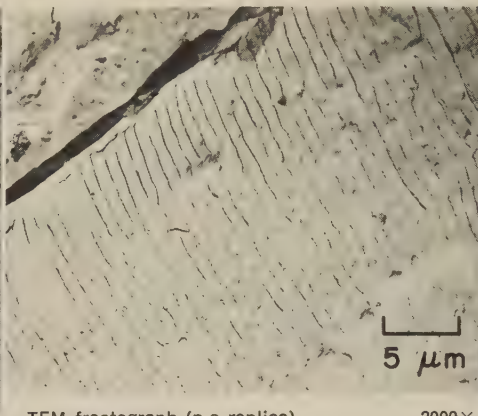
TEM fractograph (p-c replica) 2000×
5148 Surface of a fracture in a fracture-toughness specimen of aluminum alloy 2024-T851, showing a portion of the precrack area, which contains evenly spaced, gently curved tension-tension fatigue striations.

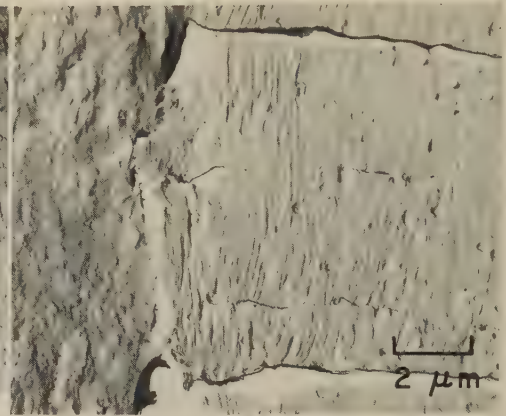
TEM fractograph (p-c replica) 5000×
5149 Surface of a fracture in a specimen of aluminum alloy 2024-T3 fatigue tested alternately *in vacuo* and in air. The nondescript surface at left formed *in vacuo*; conventional striations at right, in air.

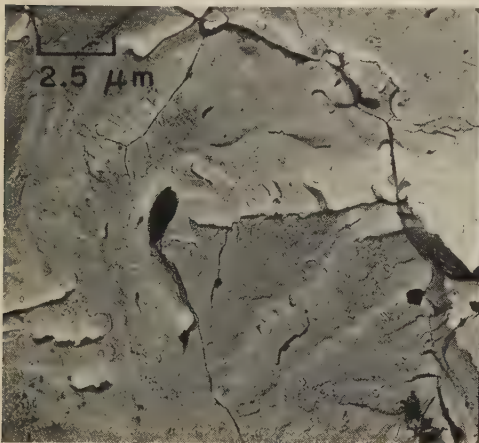
TEM fractograph (p-c replica) 4000×
5150 Surface of an intergranular fracture in aluminum alloy 2024-T3 caused by attack by liquid amalgam under minimal tensile stress. This type of attack can lead to very rapid fracture.

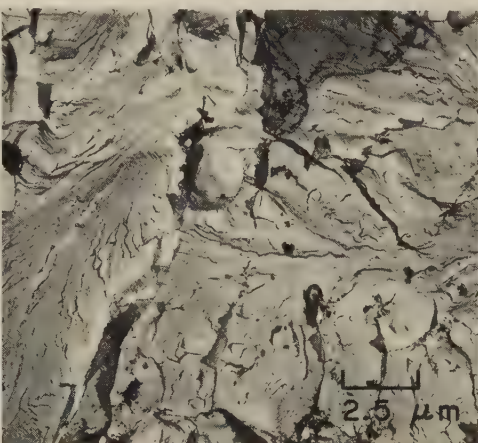
TEM fractograph (p-c replica) 4000×
5151 Surface of a transgranular fracture in aluminum alloy 2024-T3 that was induced by liquid amalgam as in fractograph 5150. The distinct river patterns visible here suggest some form of cleavage.

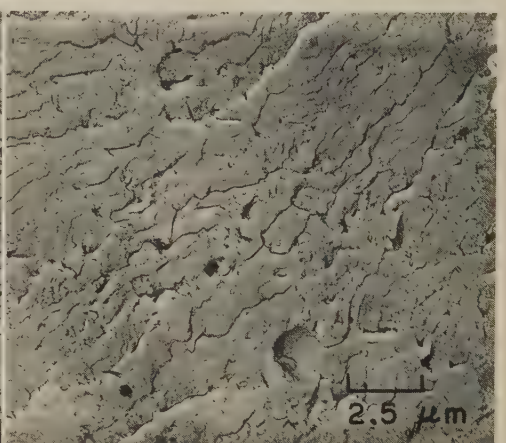
TEM fractograph (p-c replica) 4000×
5152 Surface of a transgranular fracture in plate of aluminum alloy 2024-T3, induced by liquid amalgam as in 5150 and 5151. Visible here are features suggestive of cleavage, but no river patterns.

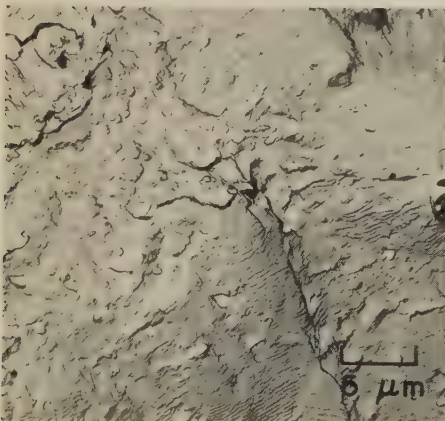
TEM fractograph (p-c replica) 2000×
5153 Tension-tension fatigue fracture in plate of aluminum alloy 2020-T651, which was stressed in the range of 14 to 34 MPa (2 to 5 ksi) at 36,000 cycles per minute. Fatigue striations interspersed with tear dimples.

TEM fractograph (p-c replica) 2000×
5154 Surface of a tension-tension fatigue fracture in a second specimen from the same plate as in 5153, showing several patches of rather vague striations, and tongue-shaped intrusions (at arrows) along some striations.

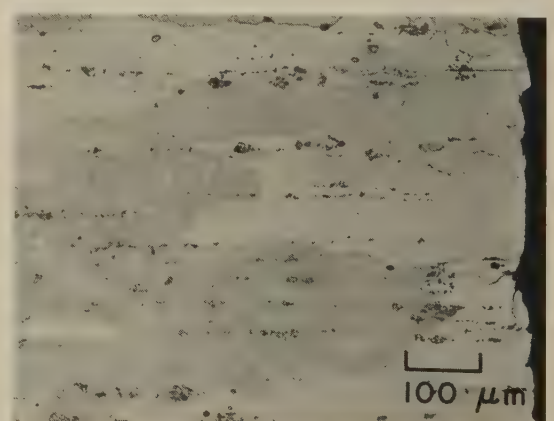
Micrograph (Keller's reagent) 100×
5155 A polished and etched section through the fatigue-fractured aluminum alloy 2025-T6 propeller blade shown in 5156 and 5157 (on the opposite page). This fracture is transgranular, as demonstrated by the profile of the fracture surface, at right.

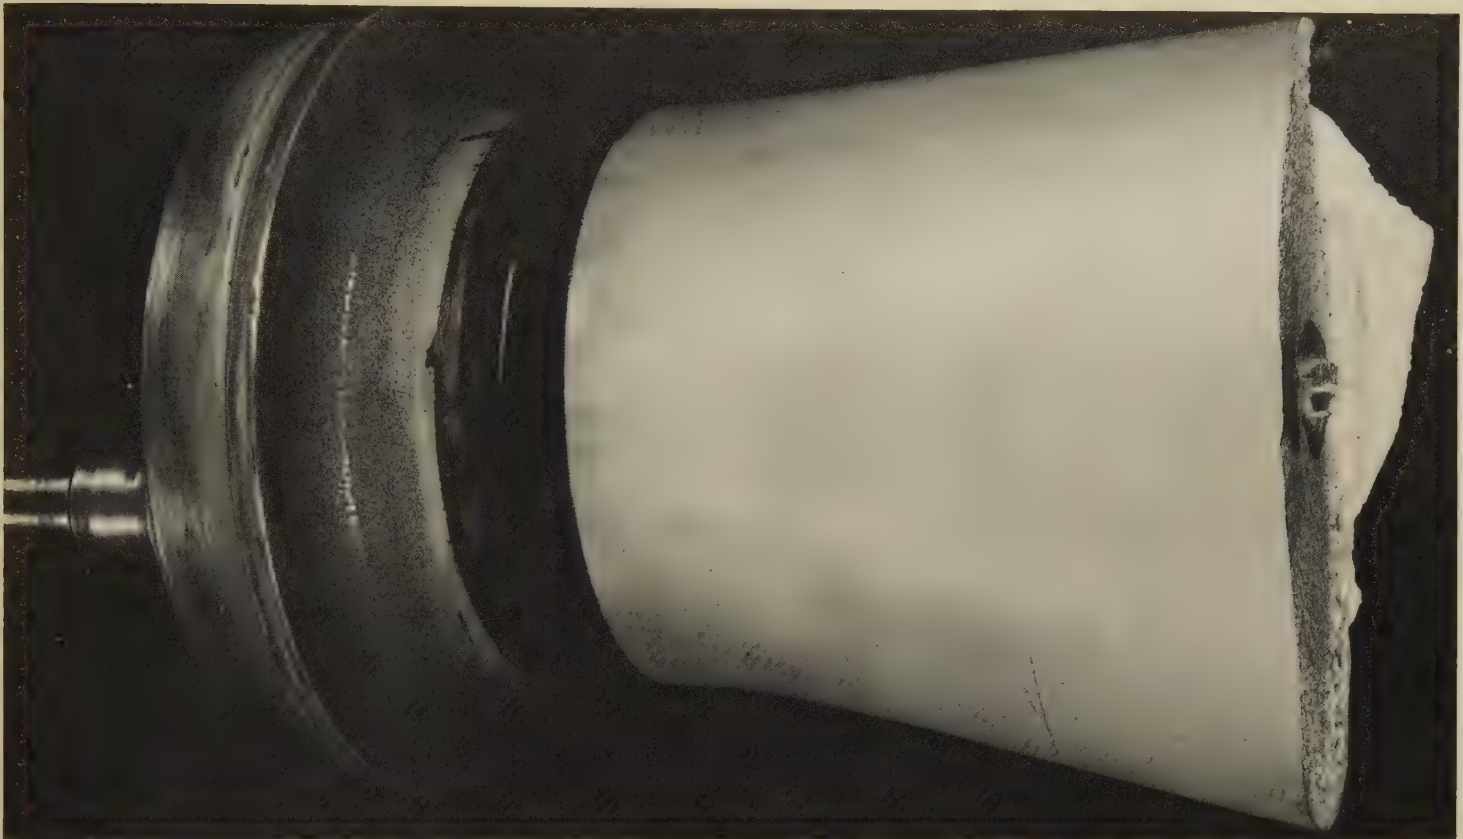
5156 A view of the shank end of a fractured aircraft propeller blade fabricated of aluminum alloy 2025-T6. The blade broke by fatigue, which originated at an interior cavity that was provided to contain a balance weight comprised of compacted lead wool. Chemical analysis established that the blade was within specified composition limits. Hardness measurements (500-kg load) yielded an average value of 107 Bhn, which was above the required minimum of 100 Bhn. See also 5155 (facing page) and 5157 (below).

5157 Fracture surface of the shank end of the broken aircraft propeller blade in 5156. The balance-weight cavity is visible at center, with the fatigue-crack origin at the upper edge (arrow). The fracture originated at the beginning of the radius that formed one end of the cavity. Examination of the cavity surface revealed severe roughness caused by tool marks and by corrosion pits. The combined effect of these tool marks and corrosion pits was considered to be the cause of crack initiation.

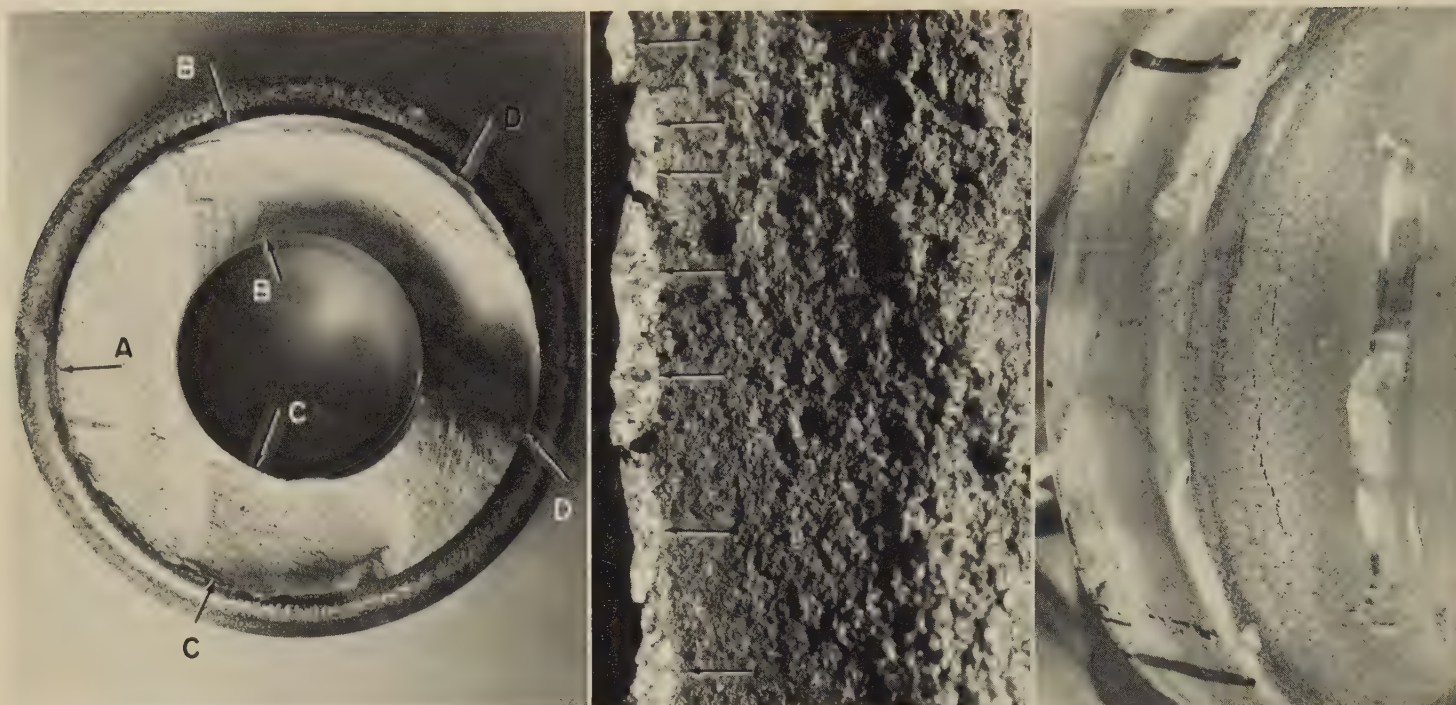
5158, 5159, 5160

At left (5158) is the surface of a fatigue fracture near the hub of an aluminum alloy 2025-T6 aircraft propeller blade. The fracture originated in a shot peened fillet. Small fatigue cracks joined to form the main crack at A, which propagated to B-B and C-C before final, fast fracture occurred. At center (5159) is a portion of the outside edge of the fracture surface in 5158, between the arrows marked D, showing small, distinct fatigue cracks (at arrows) that had been present before final, fast fracture. At right (5160) is a view of the shot peened fillet of a companion propeller blade, showing small fatigue cracks. Depth of the cold worked layer produced by shot peening was nonuniform and averaged about 0.0015 in., instead of the stipulated 0.0055 in. minimum, which afforded inadequate surface fatigue strength. See also 5161 through 5163 (below).

5161 Surface of the shot peened fillet of another companion propeller blade to that in fractograph 5158, showing the same type of fatigue cracks as those in the propeller blade in 5160. These cracks were present in large numbers in the fillet area.

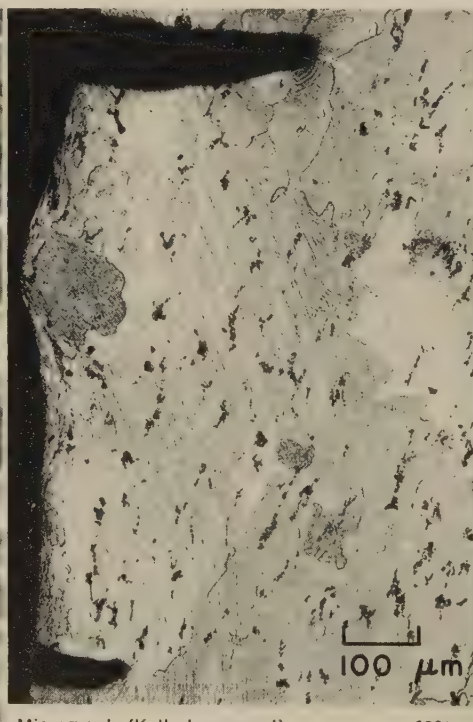
5162 A polished and etched section through the shot peened fillet of the fractured blade in 5158, showing two small fatigue cracks pulled open and blunted by plastic deformation. Note slip bands, which indicate that a slight amount of plastic flow occurred near cracks.

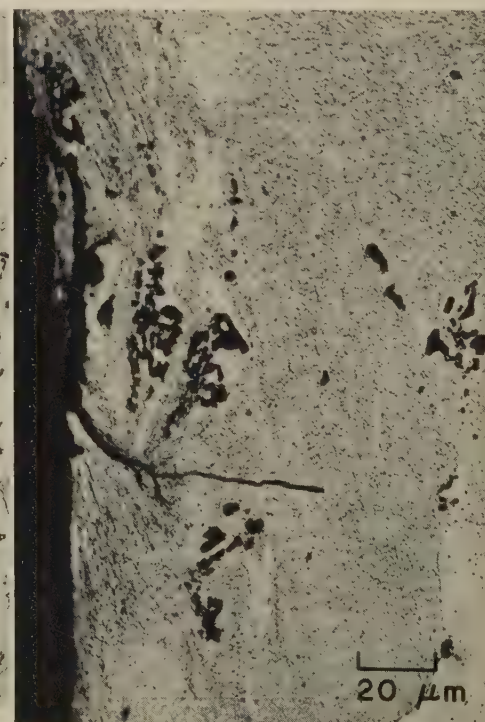
5163 Another polished and etched section through the shot peened fillet of the fractured blade in 5158, showing a fatigue crack that grew from a surface flaw. The structure indicates that only very superficial shot peening occurred here.

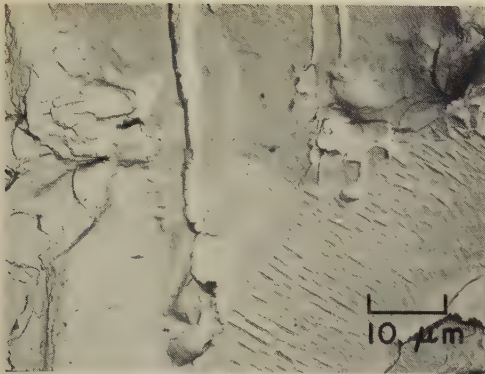
5164 Surface of a fatigue fracture in aluminum alloy 6061-T6. Fissures or secondary cracks with a spacing of $1\text{ }\mu\text{m}$ are superimposed on low-amplitude fatigue striations with a spacing of $0.15\text{ }\mu\text{m}$.

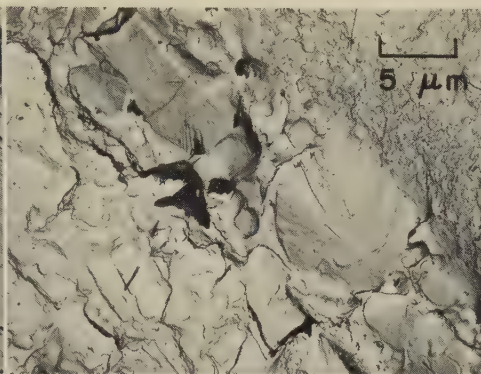
5165 Tension-overload fracture surface of a 1-in.-thick plate of aluminum alloy 7075-T6, showing very fine dimples, together with cleavage facets of several large intermetallic particles.

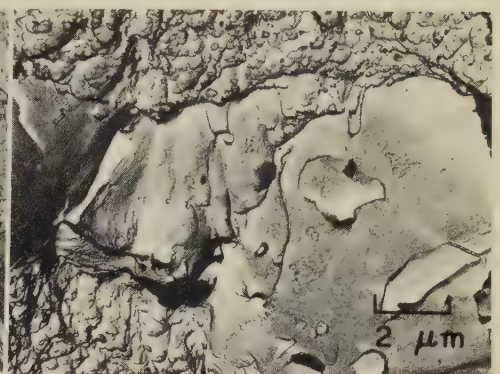
5166 Surface of a tension-overload fracture in an aircraft component of aluminum alloy 7075-T6, exhibiting a large region of stretching that contains several intermetallic particles.

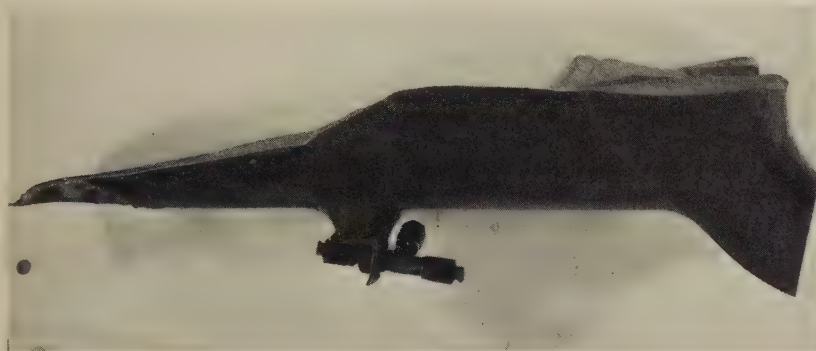
5167 A side view of a piece of a fractured aluminum alloy 7079-T6 bogie beam of an aircraft main landing gear. The fracture surface is at top, in profile. The very straight edge at lower right is a saw cut that was made to separate the fracture area from the remainder of the beam to facilitate inspection. Hardness of the beam was Rockwell B 84. See also micrograph 5168 (right) and fractograph 5169 (below).

5169 Surface of the fracture in the bogie beam shown in 5167 (above, left). Three stress-corrosion cracks caused the final, fast fracture, which was a tearing type of rupture. The intergranular attack characteristic of stress corrosion is shown in 5168 (above). The three stress-corrosion cracks are the light areas marked by arrows "b", "c" and "d". The crack surfaces appear flat but contain many small steps. Some of these steps were found to have been pulled away from the fracture surface in a leaf fashion, indicating overlapping or branching cracks. At arrow "e" is a pronounced step, which hides a portion of area "b".

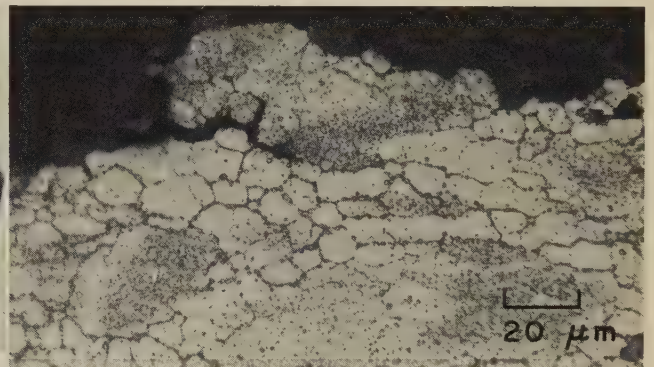
5168 Polished and etched section through the light region at arrow "d" in 5169 (below). At top in this view is the profile of the fracture surface. Note that the fracture usually followed grain boundaries. Cracks branching from the fracture surface are evident also.

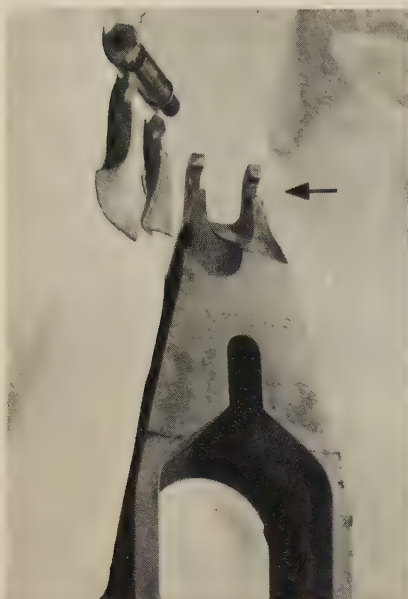
Photograph $\frac{1}{8} \times$
5170 Portion of a broken aircraft landing-gear actuator beam of aluminum alloy 7079-T6, showing stress-corrosion fractures (at arrow). See also 5171 to 5177.

Light fractograph $\frac{5}{8} \times$
5171 A higher-magnification view of the surfaces of the stress-corrosion fractures shown in photograph 5170 (left). These fractures originated at the interior edges of boltholes in clevis-attachment lugs, at the locations designated by the arrows. An appreciable amount of evidence of both corrosion and secondary cracking was found at these origins. Visible are chevron marks, which also confirm these locations as the origins of fracture.

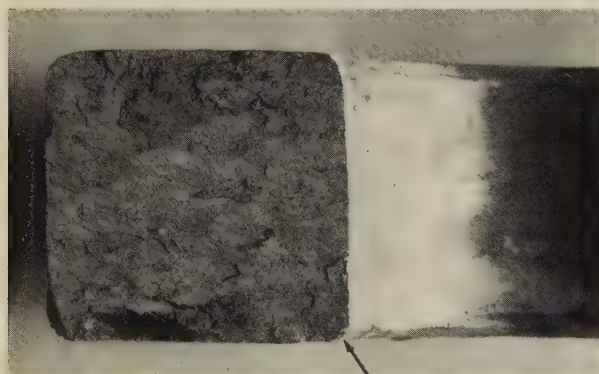
Light fractograph $4 \times$
5172 Fracture surface outboard of the bolthole in the clevis-attachment lug at right in 5171. Entire surface is typical of stress-corrosion cracking. Origin is at arrow (lower right corner of surface).

At left (5176) is a view, at higher magnification and rotated 90° clockwise, of the fracture surface in 5172 (facing page), showing more clearly the fracture-surface details resulting from stress-corrosion cracking. At right (5177) is a polished section through one of the stress-corrosion-crack origins at the arrows in 5171. The fracture surface is shown in profile at left, and the bolthole is shown in profile at bottom. Note that the crack penetrated parallel to longitudinal flow lines.

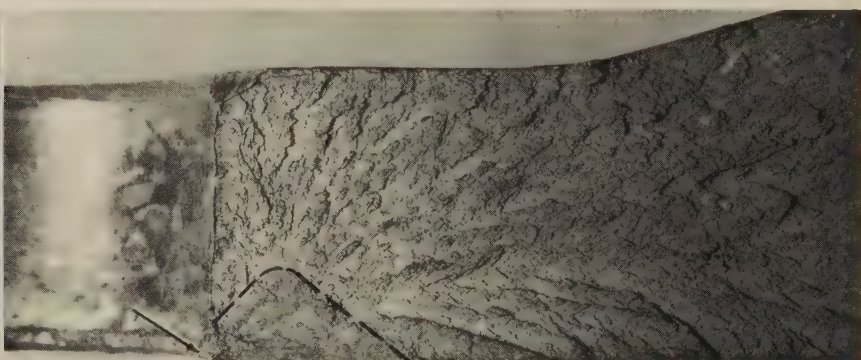
Light fractograph $4 \times$
5173 Fracture surface inboard of the bolthole in the clevis-attachment lug in 5172 (left). The primary stress-corrosion crack, which originated at arrow, is within the area enclosed by the dashed line (lower left). The remainder of this surface shows chevron marks typical of final, fast fracture.

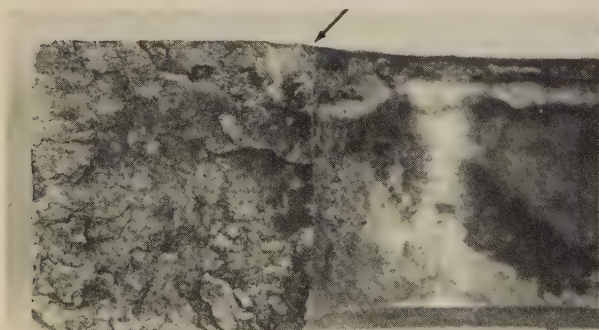
Light fractograph $4 \times$
5174 Fracture surface outboard of the bolthole in the lug at left in 5171. Here, as in 5172, the entire surface is typical of stress-corrosion cracking. Origin is at arrow (upper right corner of surface).

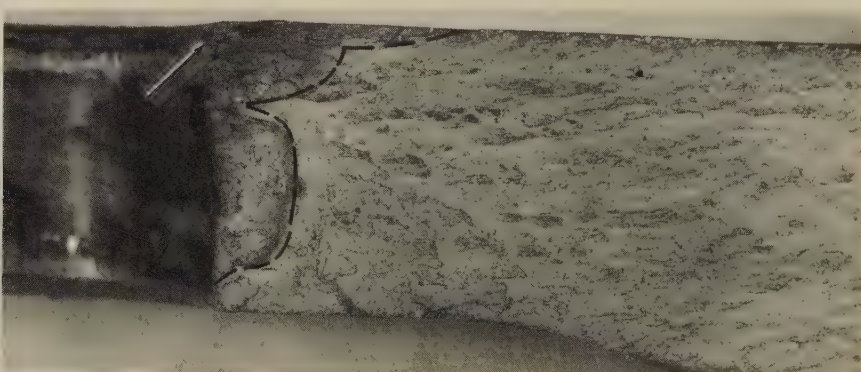
Light fractograph $4 \times$
5175 Fracture surface inboard of the bolthole in the clevis-attachment lug in 5174. The primary stress-corrosion crack, which originated at the arrow, and which is enclosed by the dashed line, is larger than that in 5173. This actuator beam had hardness normal for 7079-T6: 152-157 dph (10-kg load).

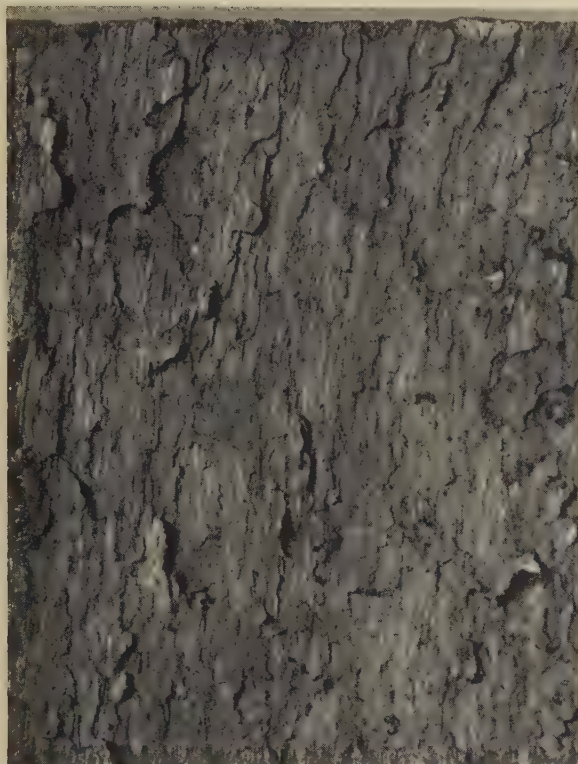
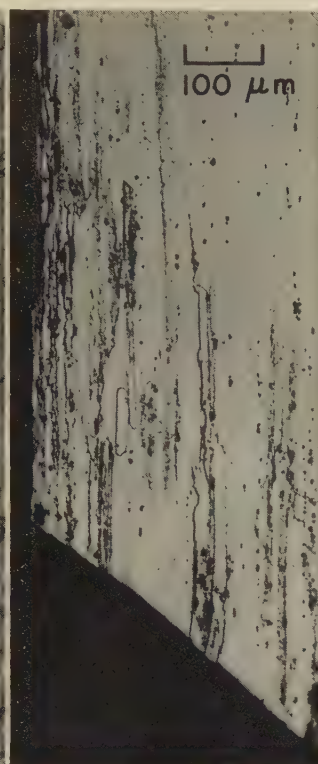
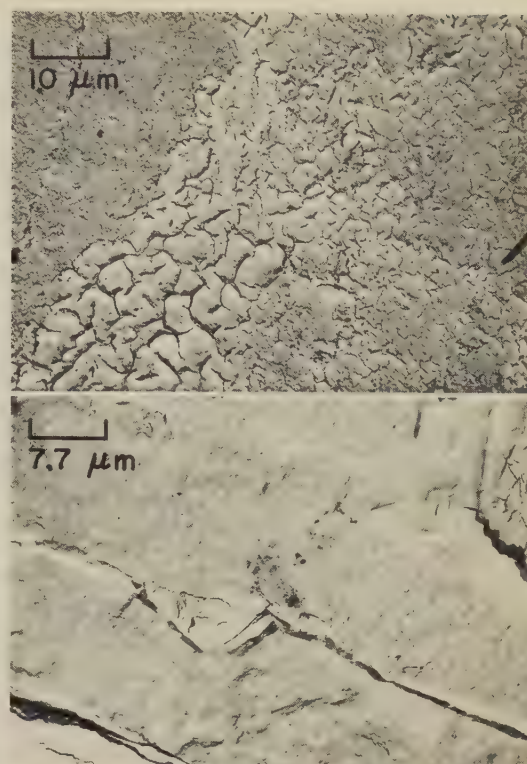
TEM views of plastic-carbon replicas of two areas of the surface of a fracture in an aircraft wing spar of aluminum alloy 7079-T651 subjected to stress-corrosion cracking (in 3.5% NaCl), showing a mud-crack pattern in 5178 (top) and a corroded area in 5179 (bottom).

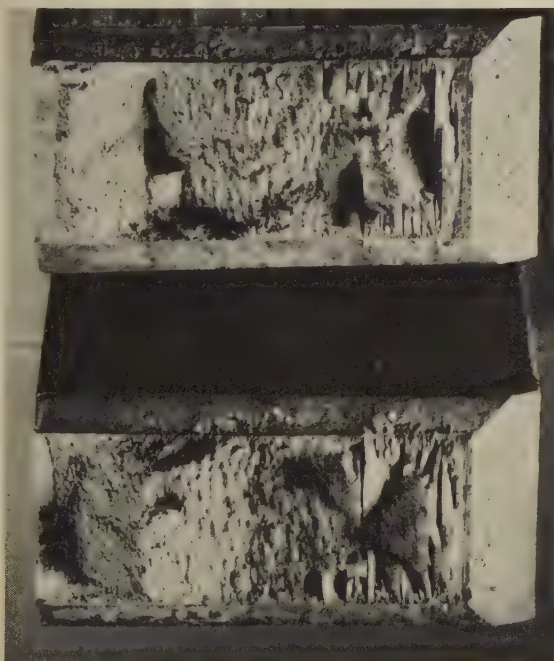
5180

Mating fracture surfaces of a stress-corrosion-cracked specimen of aluminum alloy 7106-T63 that was broken under a constant sustained stress near the tensile strength of the material (no step loading was employed). Note the cracks and steps in the fracture surfaces.

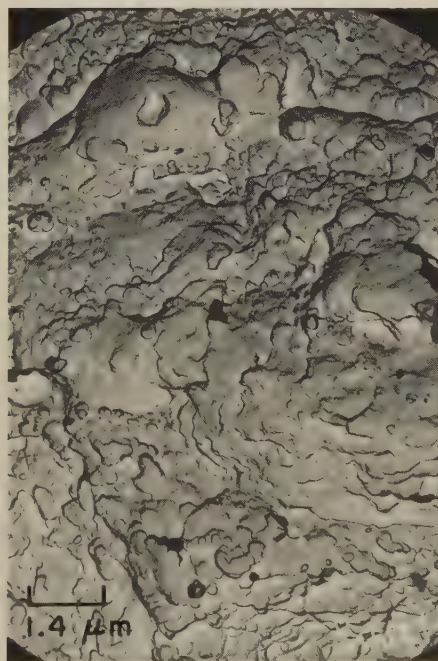
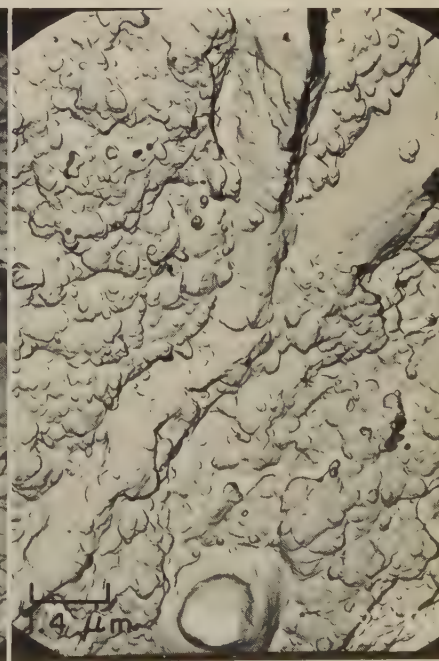
TEM views of replicas of two areas of the surface of a plane-strain fracture in a specimen of aluminum alloy 7178-T6 that was broken in monotonic (continuously increasing) tension overload at room temperature. Both of these areas exhibit dimples that are characteristic of microvoid coalescence. The long, smooth bands extending diagonally from lower left to upper right in fractograph 5182 (right) are stretched regions.

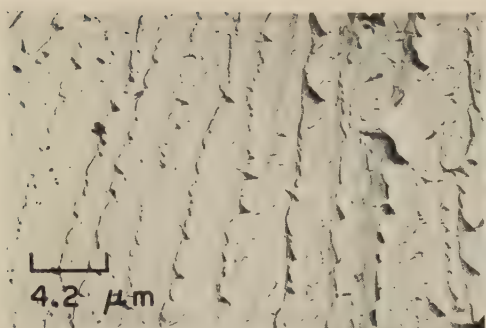
TEM fractograph (p-c replica) 2400×
5183 Cleavage fracture in a specimen of columbium bar that was broken by impact at -196 C (-321 F), showing a system of surface irregularities that resemble the tongues in specimens of Armco iron broken by impact at or below -78.5 C (-109.3 F).

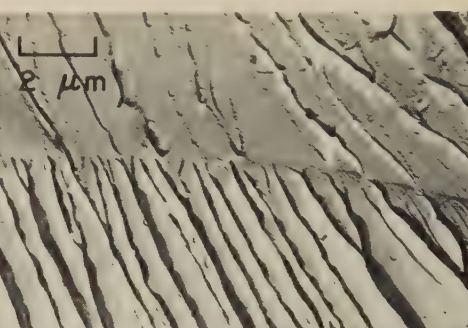
TEM fractograph (p-c replica) 5000×
5184 Cleavage fracture in a specimen of cast columbium nicked with an arc and broken by impact at room temperature, showing cleavage steps. New steps formed at the horizontal tilt-twist boundary; joining of steps occurred below the boundary.

TEM fractograph (p-c replica) 18,000×
5185 Cleavage fracture in a specimen of cast columbium that was broken by the same procedure as for the specimen in 5184, but viewed at much higher magnification. The contours of the features suggest influence of a dendritic microstructure.

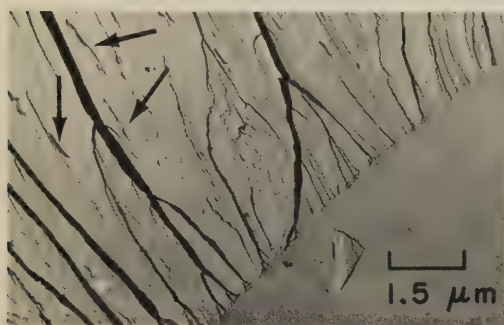
TEM fractograph (p-c replica) 6500×
5186 Cleavage fracture in columbium alloy B-66 sheet 0.045 in. thick, broken by impact. Direction of fracture, bottom right to top left. Cleavage steps originate at the grain boundary extending diagonally across the field. Note feather marks (at arrows) between steps.

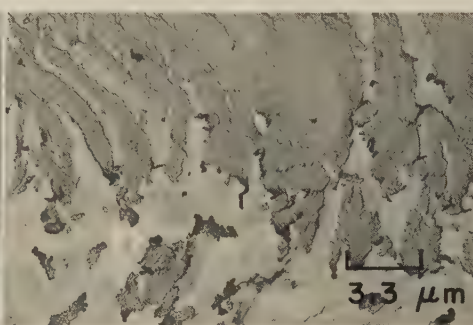
TEM micrograph (direct carbon replica) 3000×
5187 Surface of a specimen of 99.999% copper that was coated with palladium and then stretched. In stretching, the palladium coating (dark gray) fragmented instead of conforming to the deformation of the copper base metal.

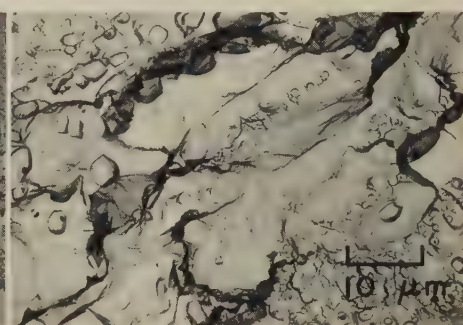
TEM fractograph (direct carbon replica) 1000×
5188 A tension-overload fracture in tough pitch copper. This area of the surface was produced by final, fast fracture in a room-temperature fatigue test. Small dimples surround cleavage facets of copper oxide inclusions.

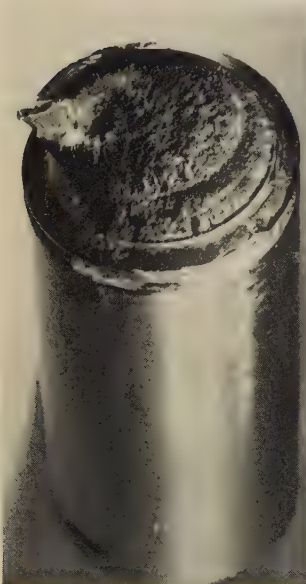
Light fractograph 2.3×
5189 Fatigue fracture in an antenna post of low-silicon bronze (~1.5% Si, ~0.5% Mn). The fatigue crack originated in the root of a very sharp V thread.
